**CONSENT ORDER
ISSUED UNDER THE
WATER POLLUTION CONTROL ACT
WEST VIRGINIA CODE, CHAPTER 22, ARTICLE 11**

TO: MarkWest Liberty Midstream & Resources, L.L.C. DATE: March 28, 2019
Gregory Bezdek, SVP, NE Region
4600 J Barry Ct. Ste 500
Canonsburg, PA 15317 ORDER NO.: 8945

MARKWEST LIBERTY MIDSTREAM & RESOURCES, L.L.C, WVR311004, Sherwood to Mobley
20" NGL, 8/22 & 8/23/2018

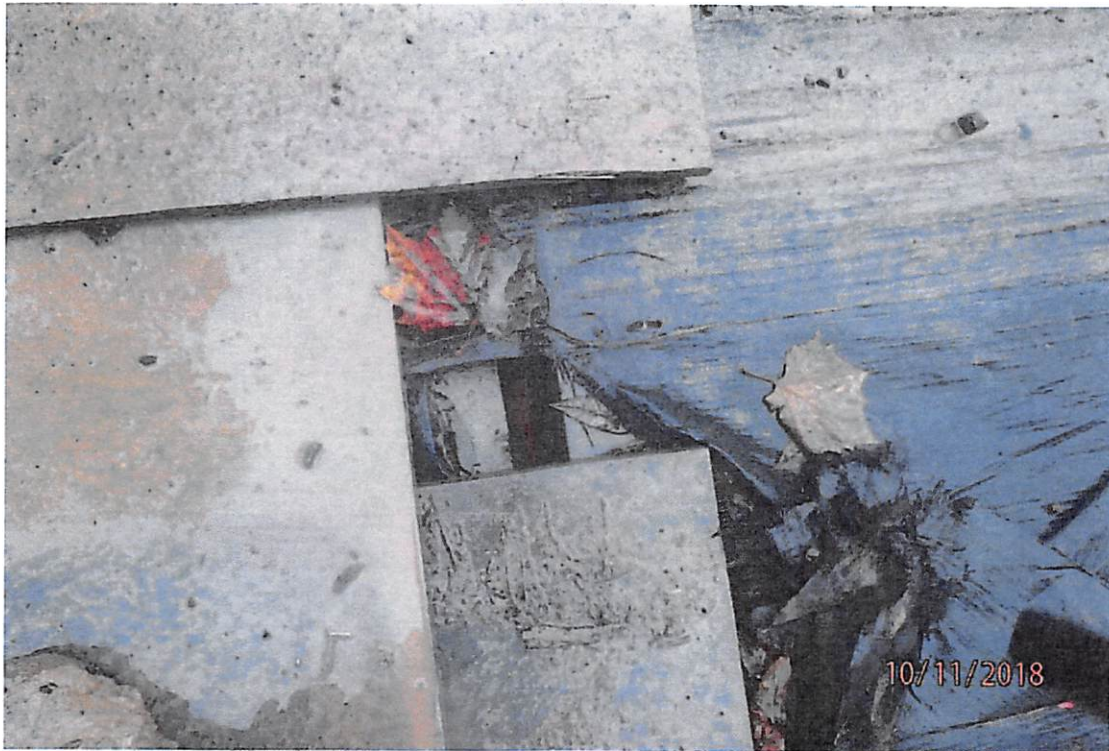
Evidence of sediment laden water bypass under the above pictured bridge (Crossing # 48).

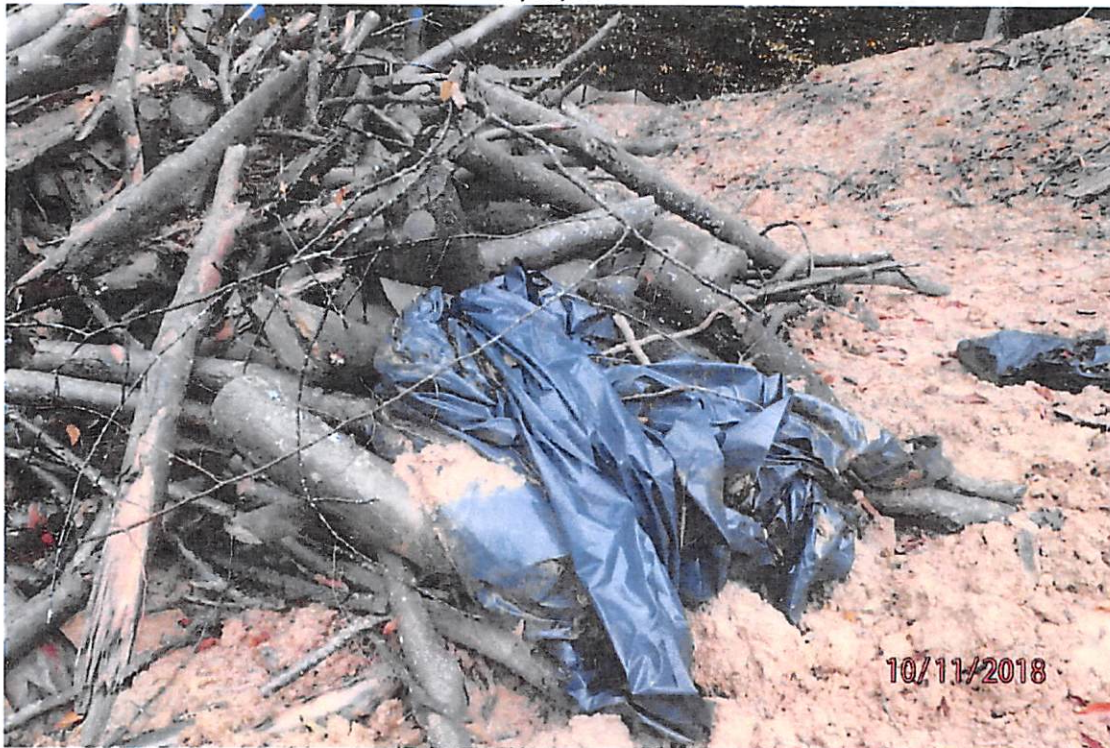
AR 42 showing sediment laden water bypassing under the installed perimeter control due to a failure to follow the SWPPP and place stone on the road.
